LakeField Platform Intel® Converged Security Engine (Intel® CSE) Firmware 13.30

Release Notes - NDA

Revision 13.30.0.1065 [BKC Release]

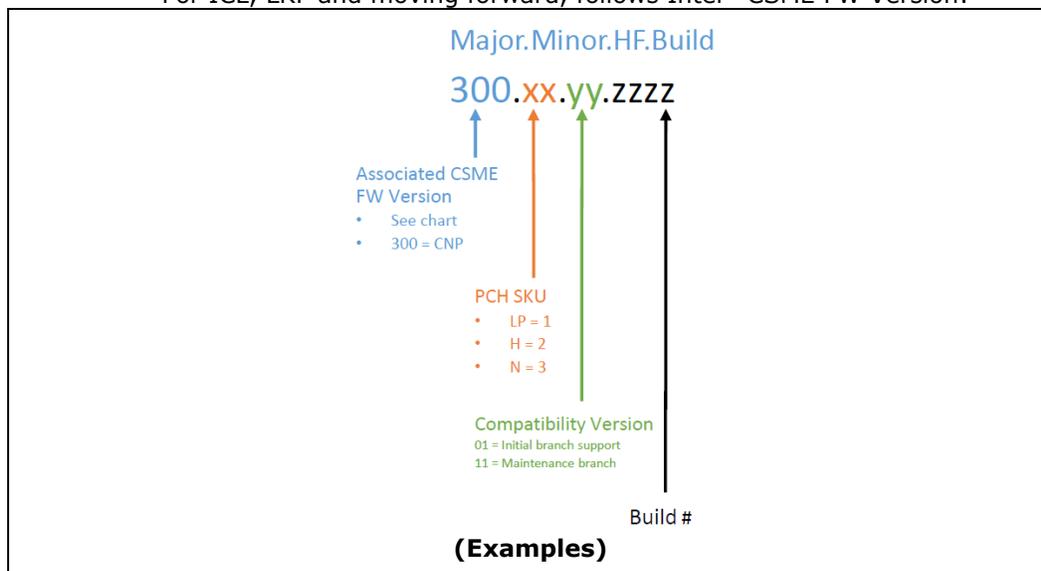
For ICL, LKF and moving forward, follows Intel® CSME FW Version:

Platform	CSME FW Version	PMC Version
CNL / CFL (ME12.0)	12.0.00.zzzz	300.2.01.1001
ICL (ME13.0)	13.0.00.zzzz	1300.1.01.1001
LKF (ME13.30)	13.30.00.zzzz	1330.0.01.1001

- **Minor = PCH SKU (Example: H vs LP vs SoC)**
 'x' refers to the Intel® PCH Type SKU PMC FW is supported for 0 = SoC (i.e. LKF), 1 = LP, 2 = H
- **HF = CVN# -Compatibility/Maintenance Version number**
 Aligned with PMC Engineering branch.
 'yy' refers to the Compatibility/Maintenance build. This field indicates when PMC FW is updated to comply with new requirements; i.e.: HW support or features.
 - 01 = Initial branch support
 - 11 = Maintenance branch with new stepping support
- **Build# -Release version**

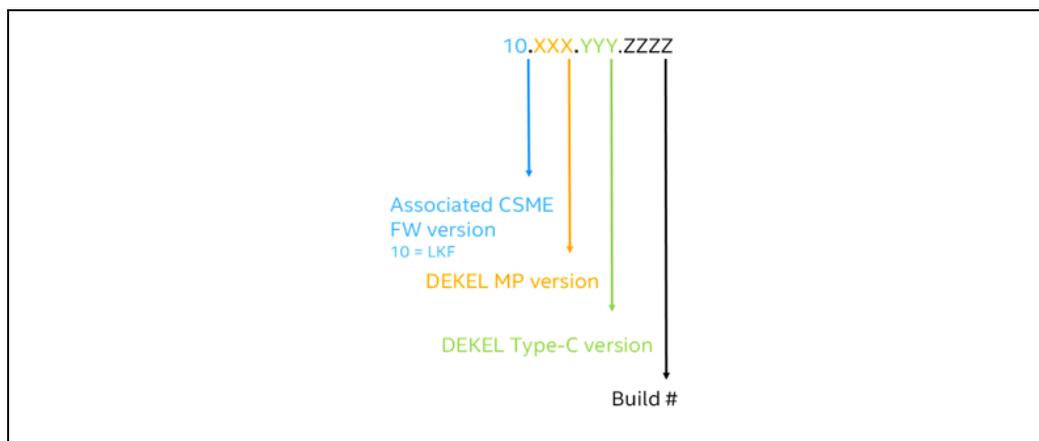
Dekel PHY FW –Release Version Numbering Information

- Dekel PHY FW consists of Multi-PHY FW and Type C FW.
- Versioning of this FW follows Major.Minor.HF.Build scheme.

- **Major** = This field Generation support of Dekel PHY FW. This 2 digits for LKF is set to 10 indicating 1st generation.
 - **Minor** = **XXX**: This 3 digits field represents the version of Multi-Phy FW embedded.
 - **HF**= **YYY** – This 3 digits field represents the version of Type-C FW embedded.
- Build** = **ZZZZ** – This 4 digit field represents the release/build version.
