# **Thunderbolt™ Release Notes For Maple Ridge (JHL8540, JHL8340)**

**Release Notes - NDA**

***Revision 5.0***

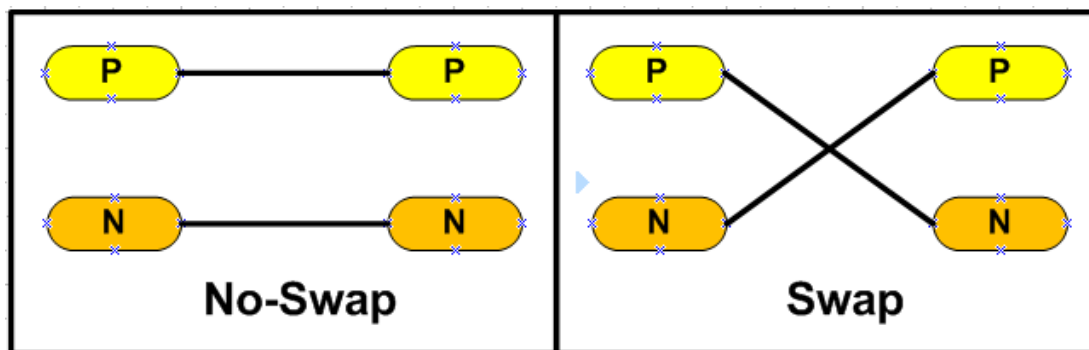
## 1.4 Lane N/P Swap Configuration

**Note:** Each revision might have different instructions on how to control board-dependent channels lanes N/P swap configuration.
